CNJ NCRS Newsletter

December 2023

Official Publication of the Central New Jersey Chapter of the NCRS

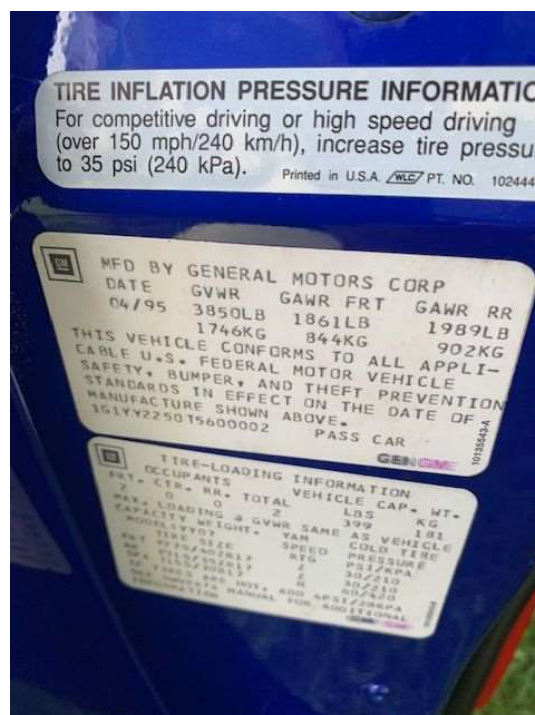
The SPIL showed it as VIN #1, but the decal on the driver side door showed it was VIN #2. What had happened with the door label with VIN #1?

Also show on the SPIL was the RPO of WD1. This RPO was identified as a Pilot Model.

She was kind enough to send me the photos of the SPIL and decals on driver side door jamb and that is when the big question became apparent.

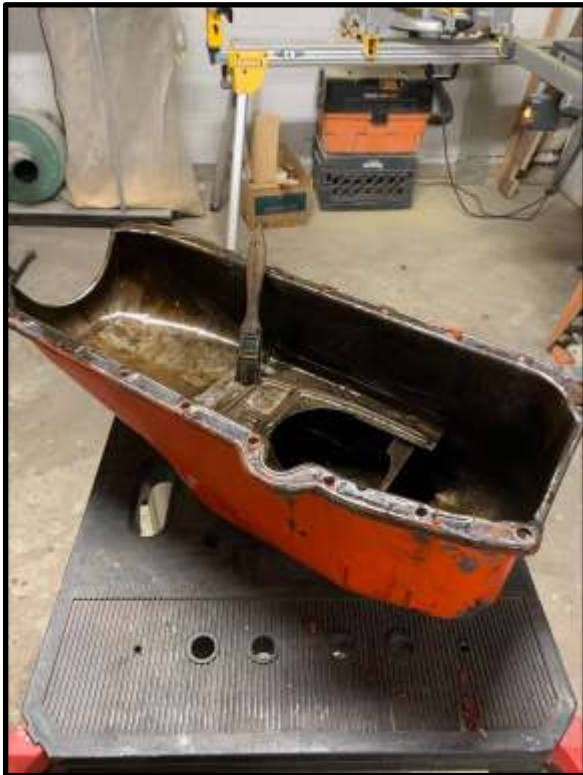
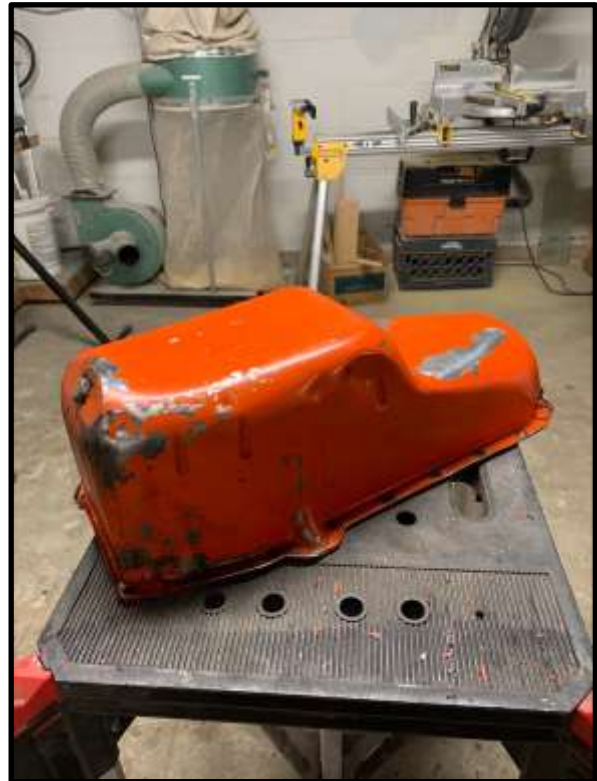
Like many old cars, the oil pan was a bit dinged, scratched, and bent in certain areas.

Step 1 – Remove and clean the pan thoroughly

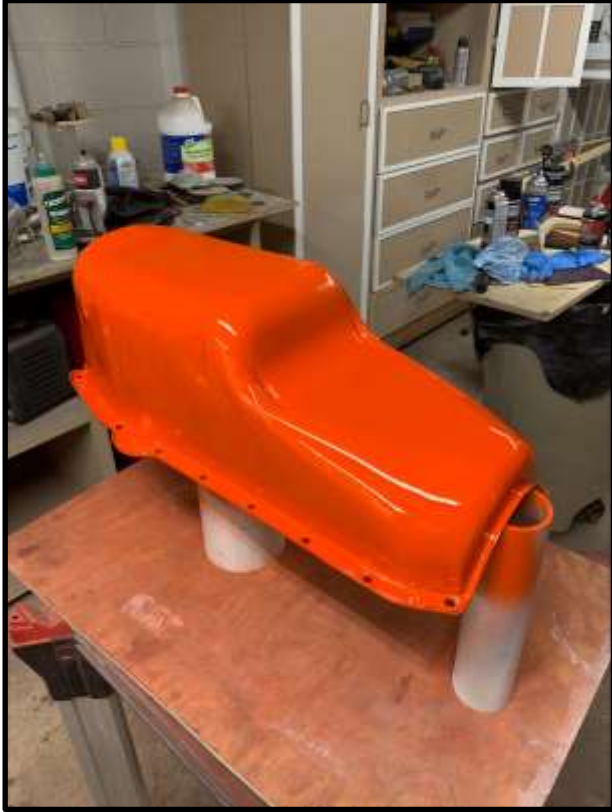
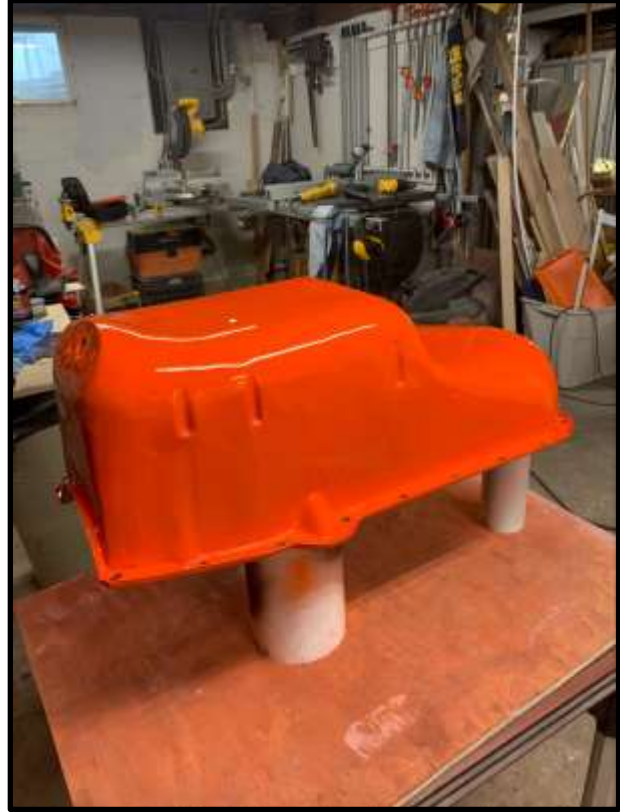
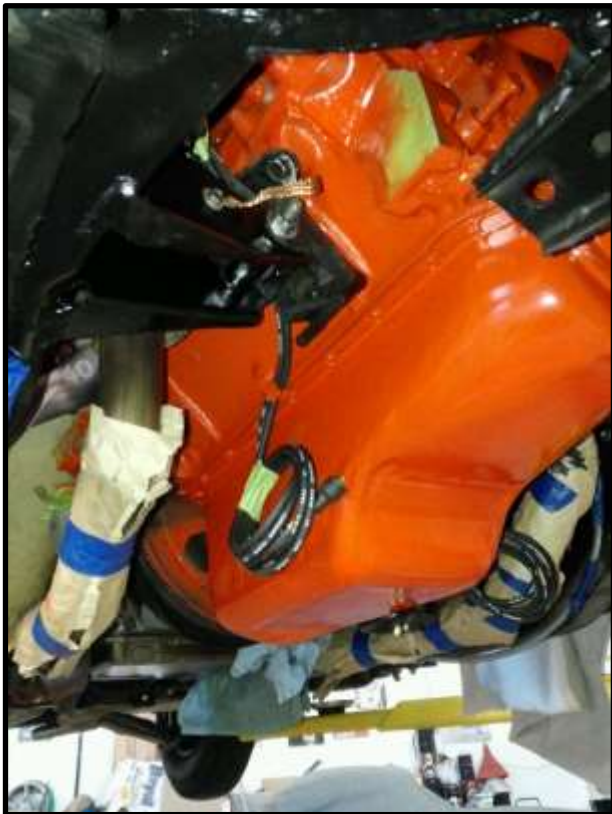
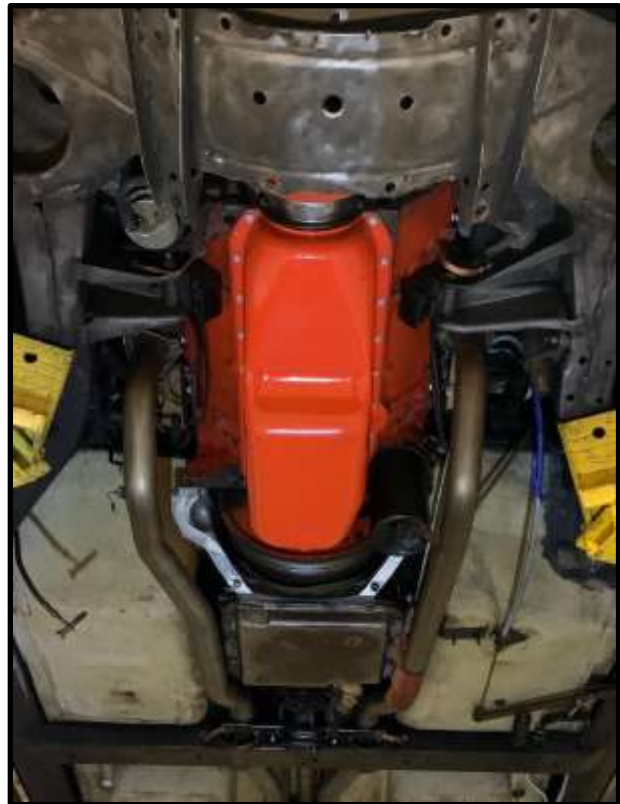
Step 4 – After the primer was completely dried, (over 24 hours) I gave it a quick wet sanding with 300 wet sandpaper then applied several coats of Chevy orange engine paint and let it dry for several days.

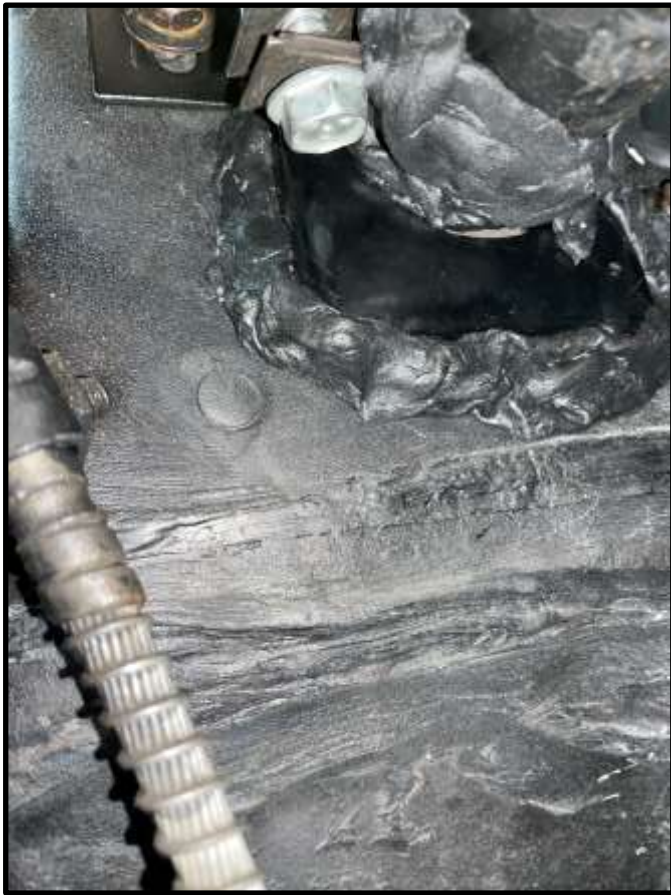
Photo 1

There is supposed to be a thick (approx. ¼") foam seal between the panel and the firewall, that was missing because the body shop either didn't know about it or forgot it. Glen ordered and installed one, and I figured at last, no more hot wind!

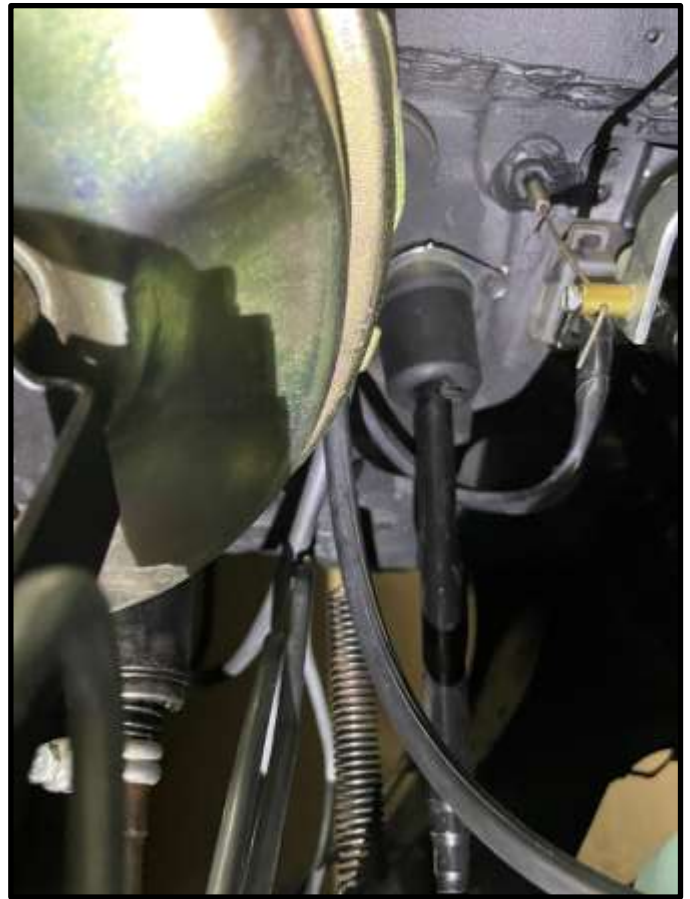
Photo 2

A test drive indicated a slight decrease in the wind, but the wind was still there. So, I proceeded to get upside down, in the driver's seat, under the dash panel and critically examine everything I could see that could possibly be open to the engine compartment. There was a gap around the steering column and the floor panel, about ¼" around the column, to allow clearance for the column to go thru. But I couldn't figure out how it would matter, since I had already sealed the steering column to the firewall, under the hood. You could see a space between the floor panel and the firewall, so I figured what the heck, seal that too. So, I did. See Photo 3.

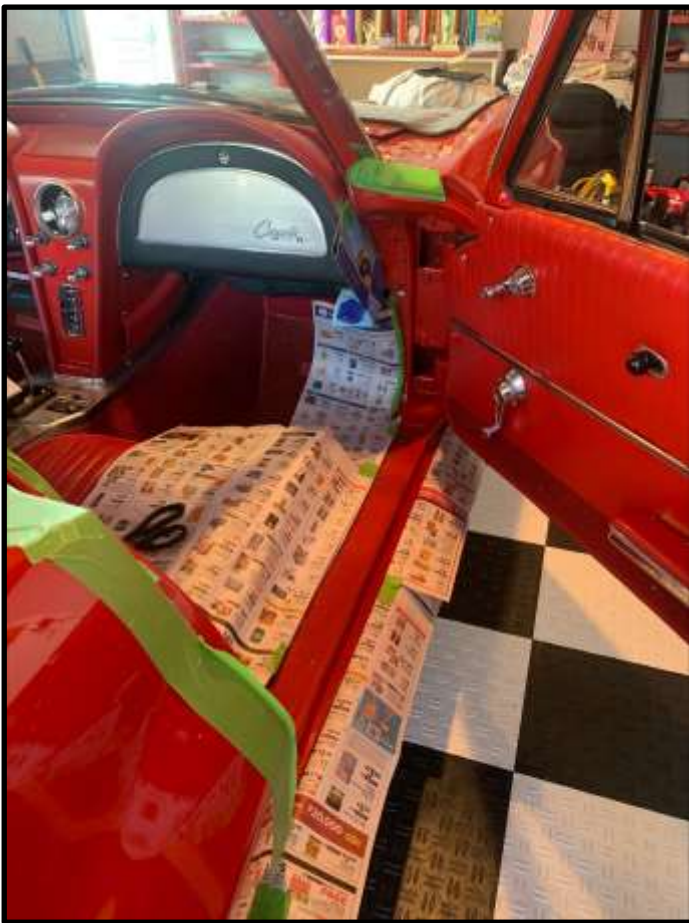
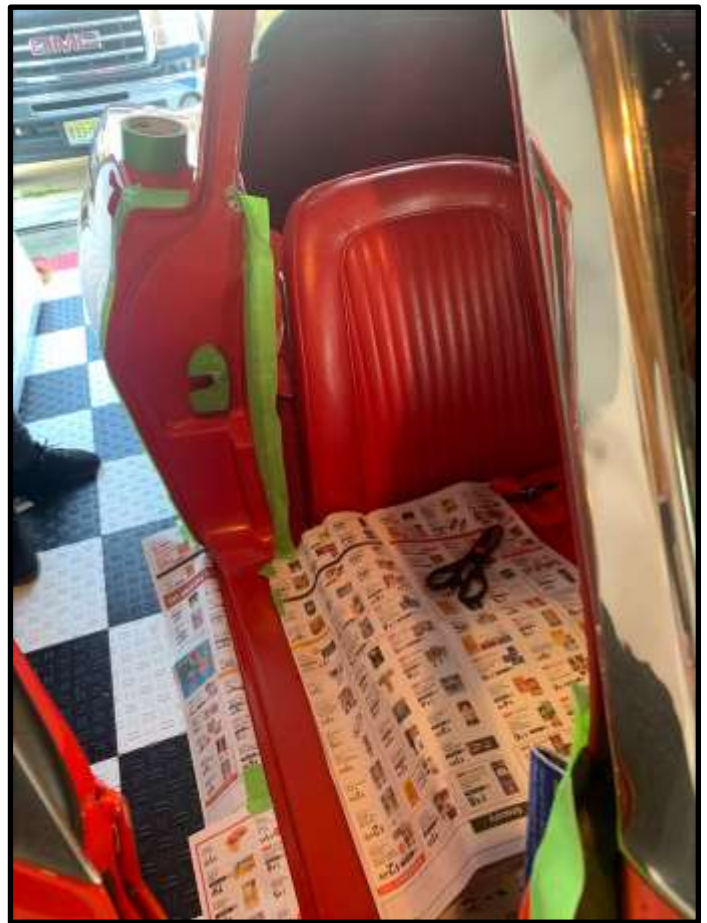
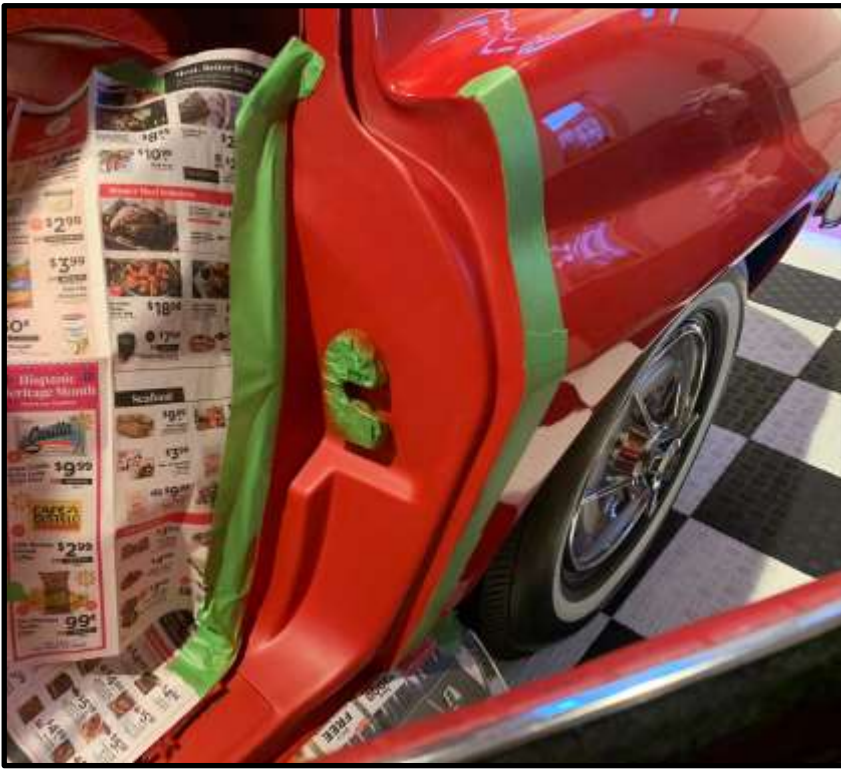
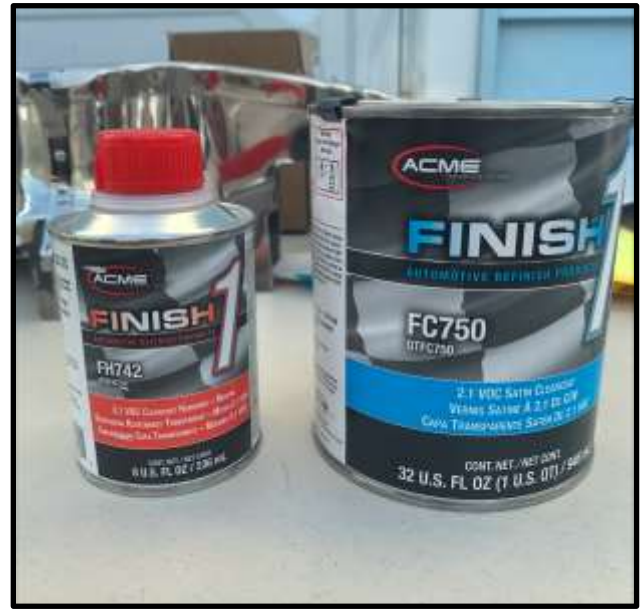
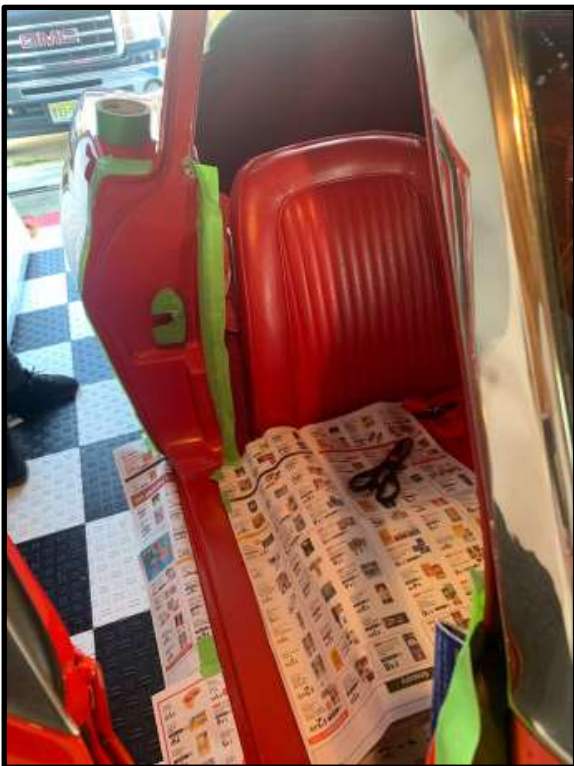
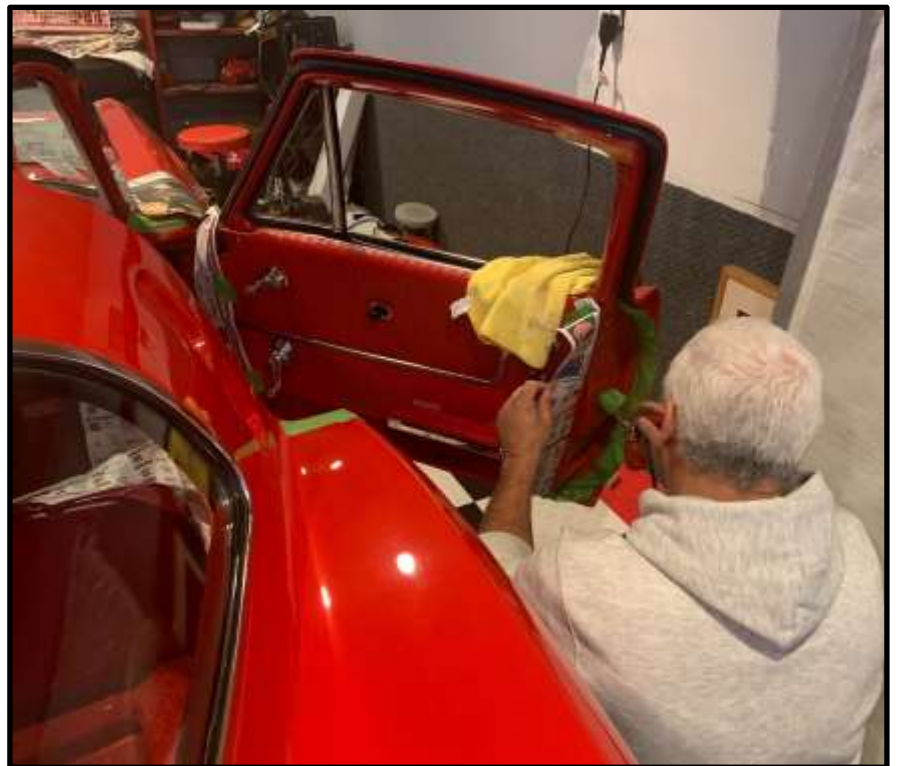
The beauty of an air brush is that you can get the same results as a large paint gun only in miniature size and with minimal damage.

Here are some pictures of the process
